RESIDENTIAL REPORT

1234 Main St. St-Lazare QC J7T 3L7

Inspector
Karol Bartnicki

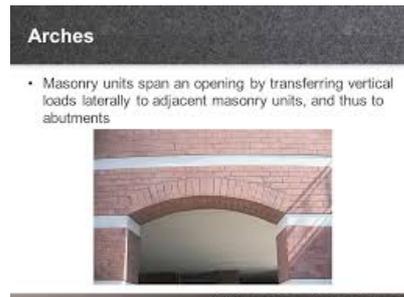
Lintels:

Brickwork needs to be supported over openings. There are five methods of doing this: brick arches, steel bars or angles, prefabricated reinforced concrete, prefabricated brickwork and directly from the reinforced concrete structure. The steel angles (known as shelf angles), can provide all the support, or be attached to the primary structure such as a reinforced concrete frame, to which the load is transferred.

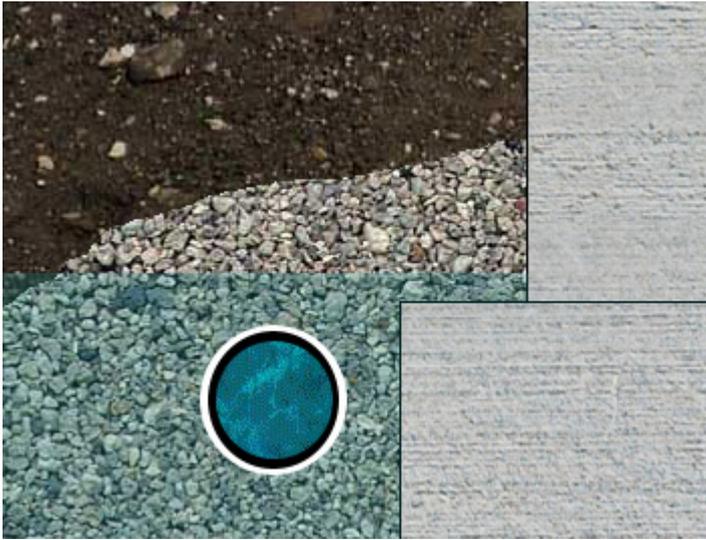
Here is a cross-section of a French drain system running along the cement footing of a foundation. It shows the drain (blue with water), the crushed stone it rests in, and surrounding replacement soil.

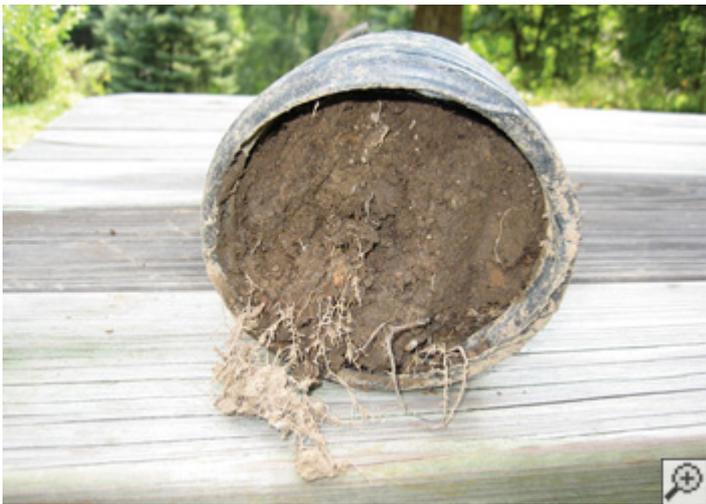
This is a section of a completely dirt-packed drain system from a house in Montreal, QC.

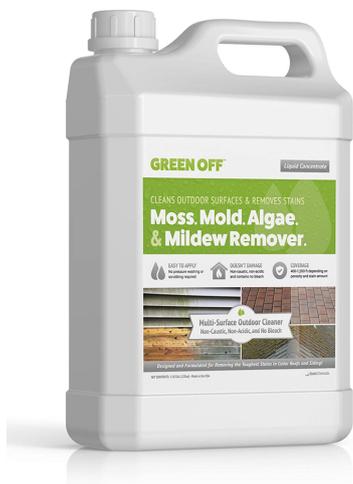
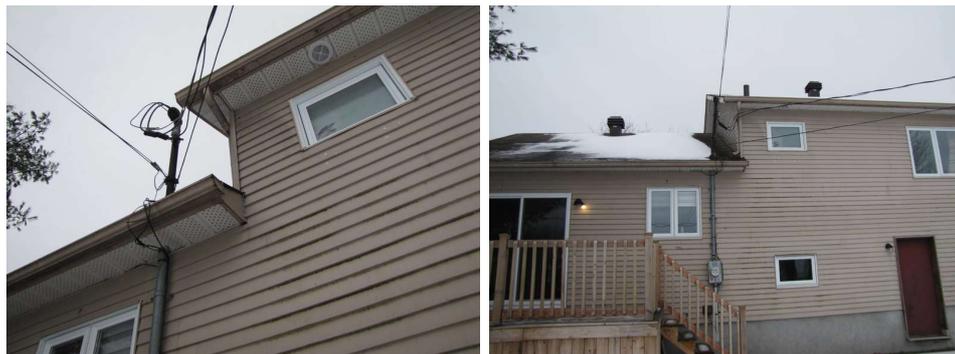
Green stains on siding are usually the result of mold, mildew, algae or moss. These stains occur naturally over time. When house siding begins to turn green, it diminishes the exterior appearance of the home.

Recommend that said areas be washed or cleaned on a regular basis.

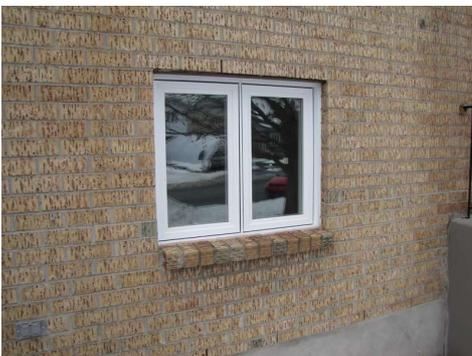
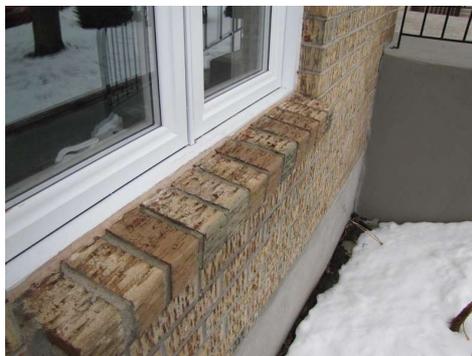
Cracks between the bricks are visible allowing water infiltration into the wall below

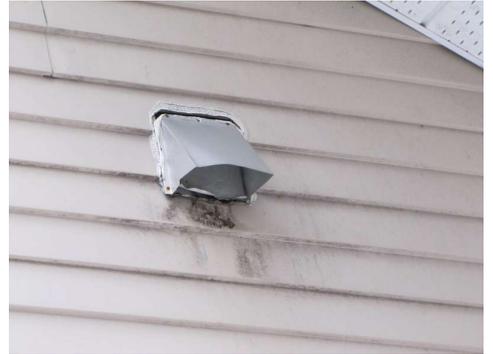
It appears the the vent is not functioning properly.

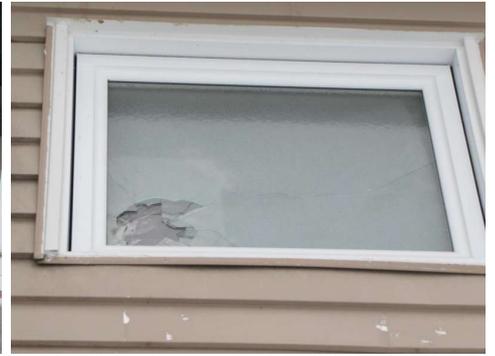
Back of the house second floor broken glass

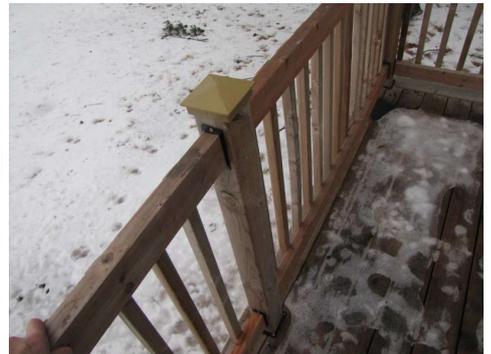
Back balcony the railing was loose

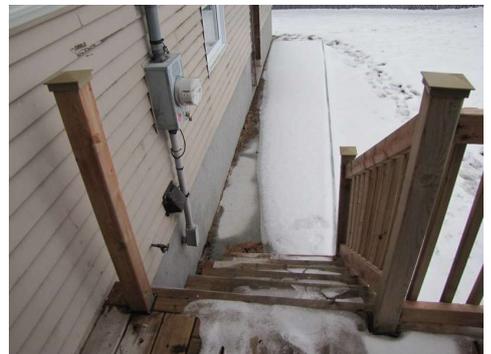
Back wooden balcony

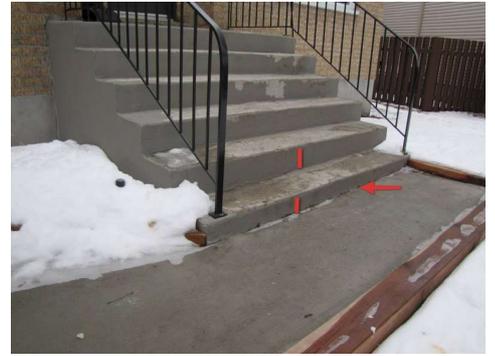
First step is much shorter than the others

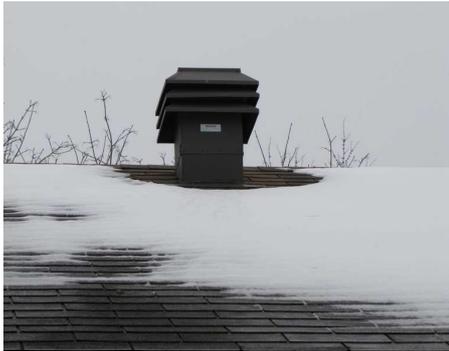
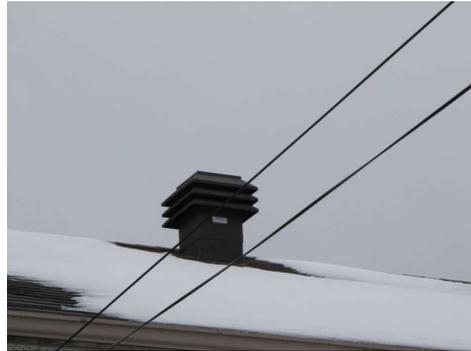
Skylights, Chimneys & Other Roof Penetrations: Plumbing Vent

It is a vertical pipe attached to a drain line and runs through the roof of your home. The vent stack is the pipe leading to the main roof vent. It channels the exhaust gases to the vent and helps maintain proper atmospheric pressure in the waste system.

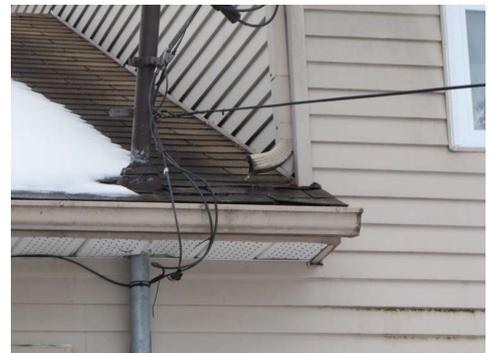
Shingles damaged due to gutter downspout. recommended to relocate the downspout to the other side

Recommend a qualified roofing professional evaluate and repair.

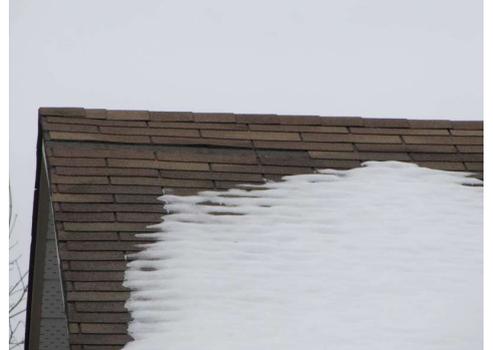
SHINGLES - MISSING

Observed areas that appeared to be missing sufficient coverings.

When roof shingles go missing, they open up the only weather shielding your house has to severe weather, heat, cold, and moisture. If those missing roof shingles aren't fixed quickly, your roof and home can sustain permanent damage.

Recommended to contact a qualified roofing contractor evaluate & repair.

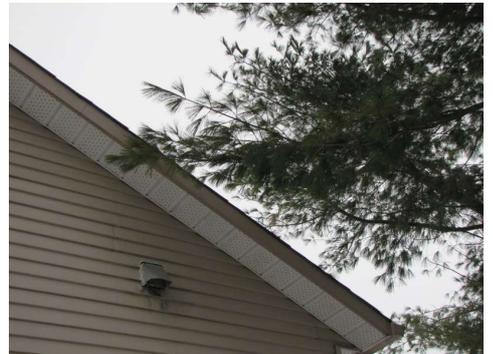
4.1.4 Coverings

TREES TOUCHING THE ROOF

- 1. As branches scrape against roof shingles on windy days, they can strip off layers of asphalt.
- 2. Their leaves fall directly onto your roof or into the gutter, which can lead to mold, deterioration or leaks.
- 3. Even worse, if the tree is damaged or diseased, a storm can cause limbs to fall onto your home.

Contact a qualified professional.

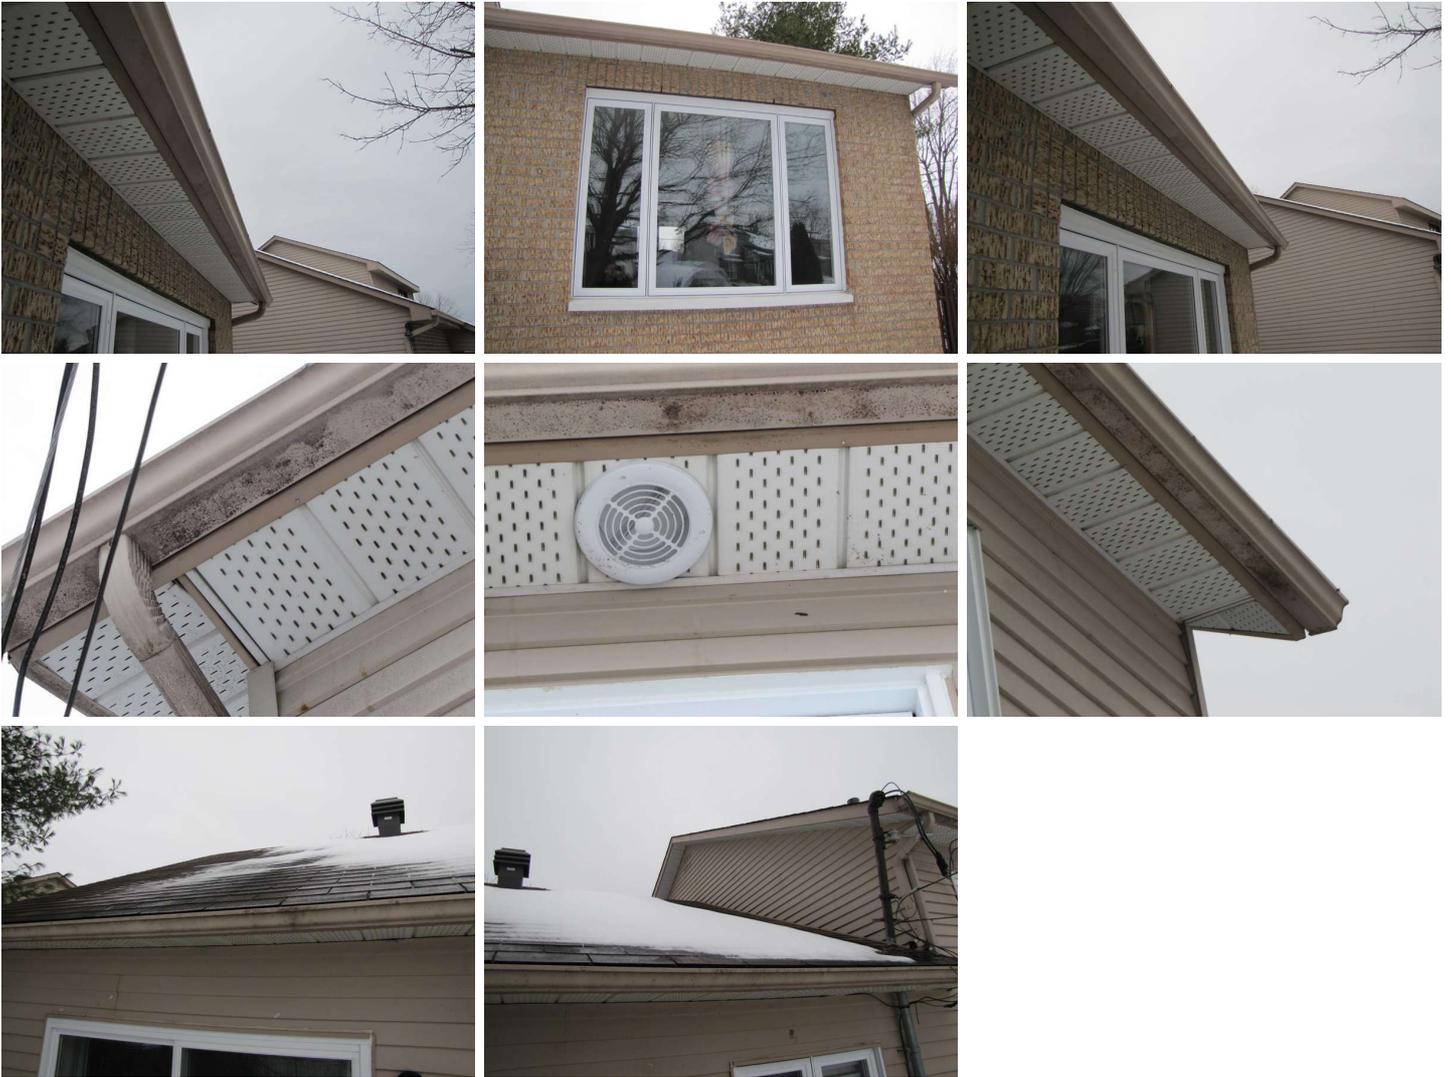
GUTTER LEAKAGE

Visible staining on the gutters indicates that the gutters are leaking in one or more areas. This can result in excessive moisture in the soil at the foundation, which can lead to foundation/structural movement. Recommend a qualified contractor evaluate and repair gutters to proper functionality.

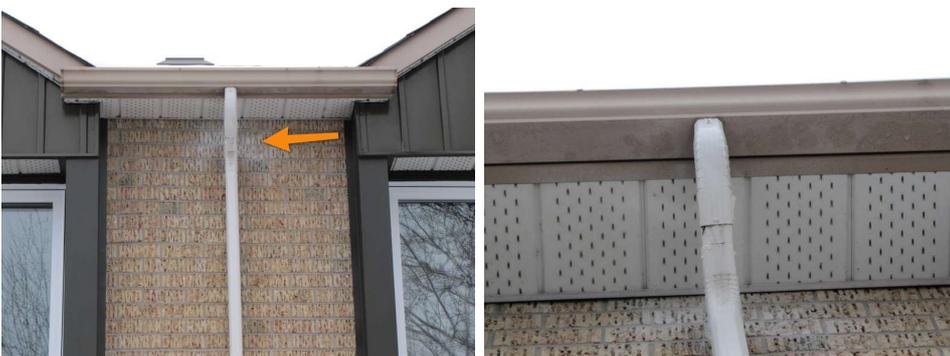
4.2.2 Gutters and Roof Drain

GUTTER DOWNSPOUT - CAUSING DAMAGE

Due to improper installation the gutter downspout is causing damage to the brick wall, efflorescence is visible on the brick wall directly behind the gutter elbow.

Contact a qualified professional.

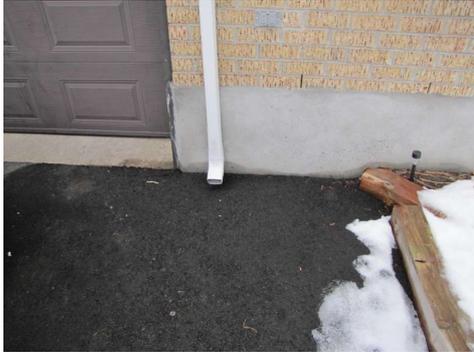
Gutters were damaged. This can result in excessive moisture in the soil at the foundation, which can lead to foundation/structural movement. Driveway will become icy and slippery which could pose a slip hazard. Recommend a qualified contractor evaluate and repair.

Redirect the downspout, possibly under the surface to the street

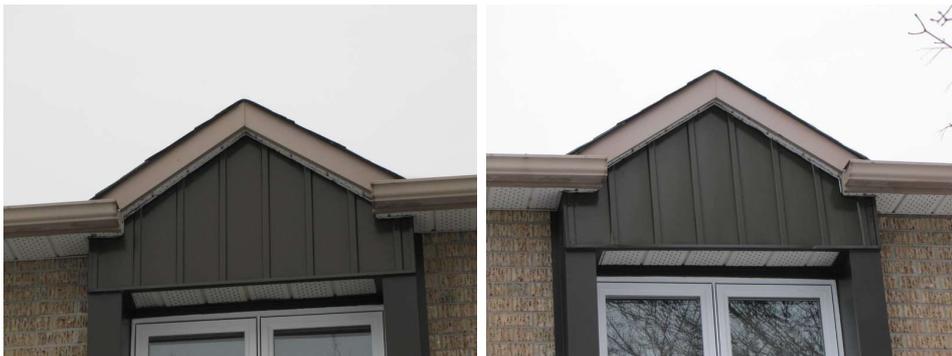
4.3.1 Flashings & Soffits

DRIP EDGE FLASHING - MISSING

- Protects the shingles from potential water damage, which otherwise may cause the roof, deck, and fascia board to erode over time.
- Pushes water away from the fascia and reduces the risk of it eroding over time.

- Guards the underlying roofline against damage in the winter months such as ice and snow damage, which could result in rotting.
- Safeguards the roof from strong gusts of wind and wind-blown rain.

Contact a qualified professional.

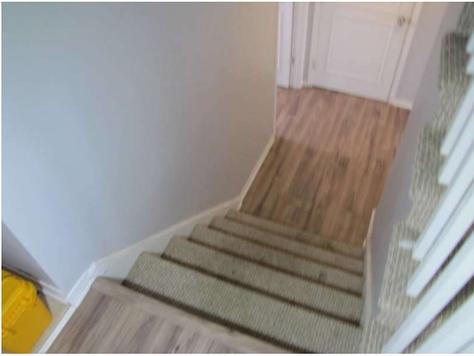
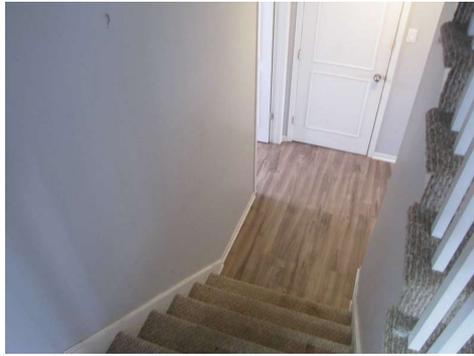
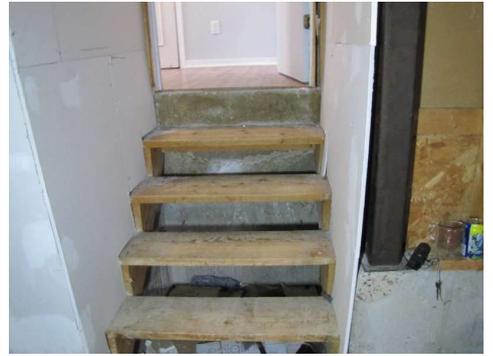
5.1.1 Steps, Stairways & Railings

HANDRAIL - MISSING

A handrail must be easy to locate, provide continuous support, and have a shape that makes it easy to hold on to. It must be at least 50 mm (2 in.) from any continuous surface, and must not encroach by more than 100 mm (4 in.) on the required width of the stairwell. The ends of the handrail, moreover, must not be in any way dangerous to people with limited vision, or to childrens heads, or to anyone wearing loose clothing or carrying cumbersome items up or down the stairs.

A single handrail is enough if the stairway is less than 1,100 mm (43 in.) wide. Any stairway wider than that requires a handrail on each side (exception: inside a dwelling, the 2010 NBC allows for a handrail on one side only). And in the case of a exterior staircase that is curved, regardless of its width, there must be handrails on both sides.

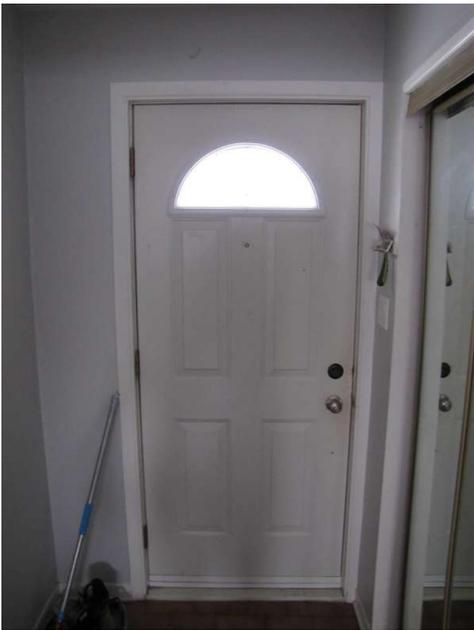
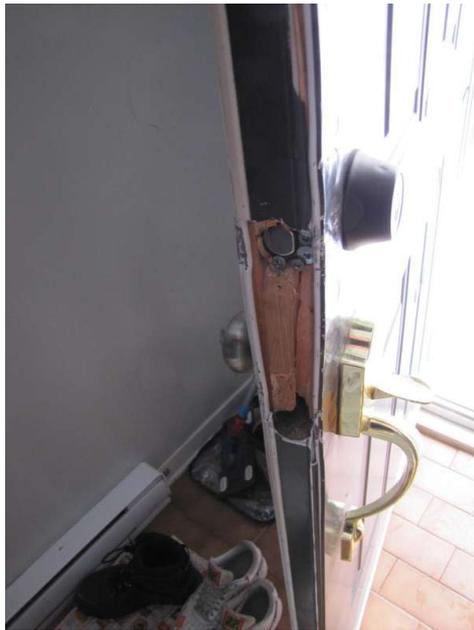
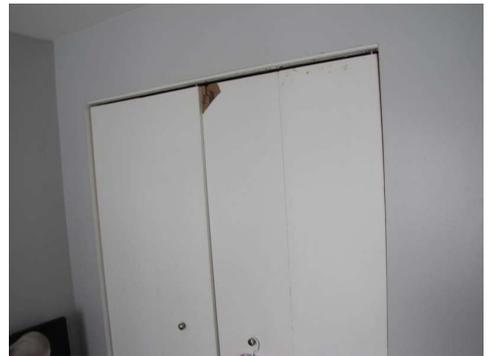
5.3.1 Doors Interior View

DOOR - DAMAGED

Front door is damaged and will require replacement

Contact a qualified professional.

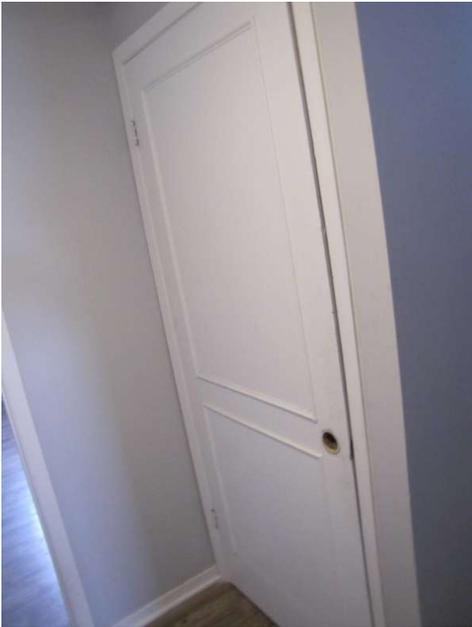
5.3.2 Doors Interior View

DOOR KNOB - MISSING

Knob was missing on the basement door, new knob is required.

Contact a qualified professional.

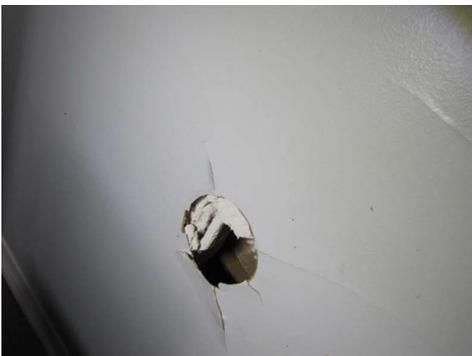
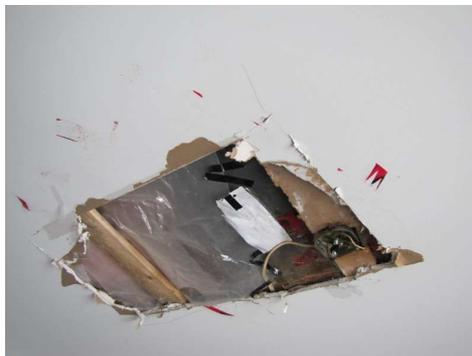
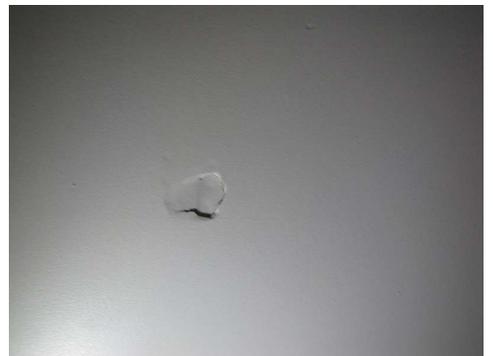
5.4.1 Walls Interior

DAMAGE

Considerable wall and ceiling finishing damage, visible in few areas.

Repairs will be required

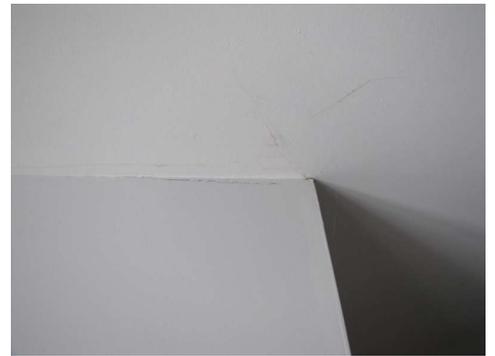
Living room

MINOR DAMAGE/CRACKING

Most homes have them: small cracks in the ceiling that seem to appear out of nowhere. Although they can occur for many reasons, are the ones in your home simply cosmetic or cause for concern?

- In many homes, spiderweb cracks are common mainly due to age, and are of cosmetic concern only: they may occur and appear on the walls, in joints, and on the floor.
- On the other hand, large cracks that measure more than 1/16th of an inch wide should raise concerns about a structural defect.

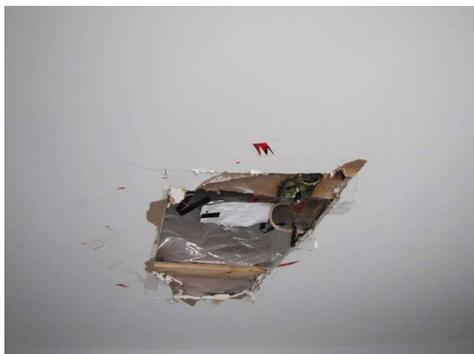
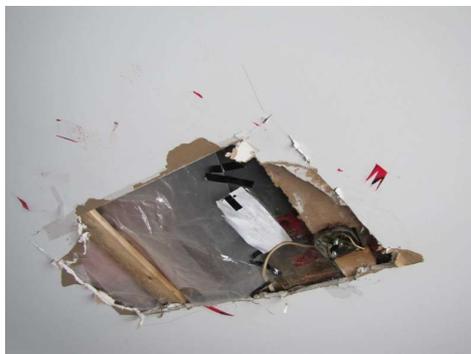
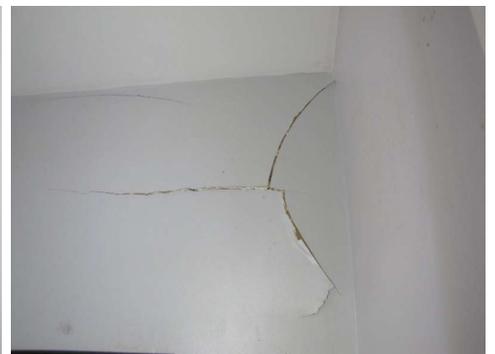
5.5.3 Ceilings Interior

SEVERE DAMAGE

Severe ceiling damage observed. Recommend a qualified drywall contractor evaluate and advise.

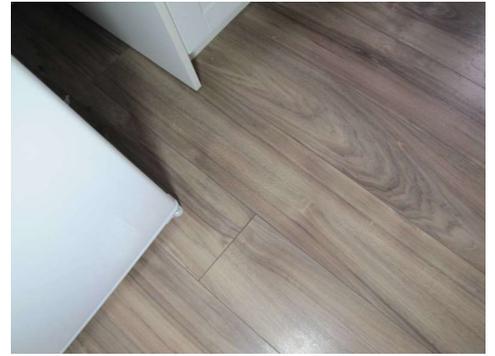
5.6.1 Kitchen

FLOOR - DAMAGE

Visible floor water damage in the kitchen, replacement is recommended.

Under the fridge area

Contact a qualified professional.

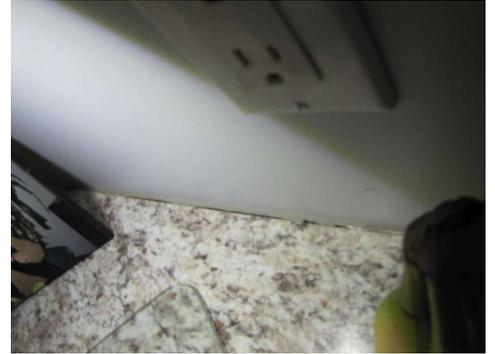
5.6.2 Kitchen

COUNTER - CRACKED SILICONE

It is recommended to re-apply silicone along the back edge of the counter to prevent any water infiltration.

Contact a qualified professional.

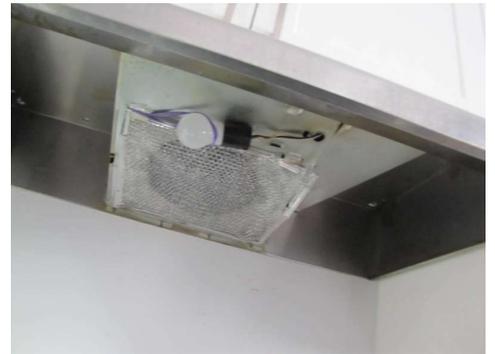
5.6.3 Kitchen

EXHAUST FAN - NOT EFFICIENT

Exhaust fan was not functioning properly. Verifying the ducts or replacement for more efficient unit is recommended.

Contact a qualified professional.

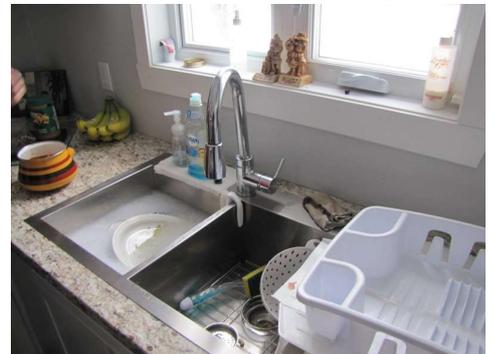
5.6.4 Kitchen

FAUCET - LOOSE

Faucet was moving, recommended to have it repaired by a plumber.

Contact a qualified professional.

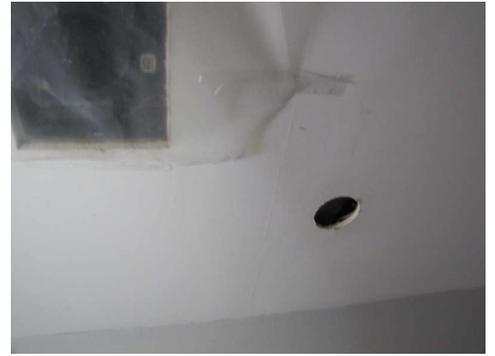
5.7.1 Bathrooms

EXHAUST FAN - MISSING COVER

Contact a qualified professional.

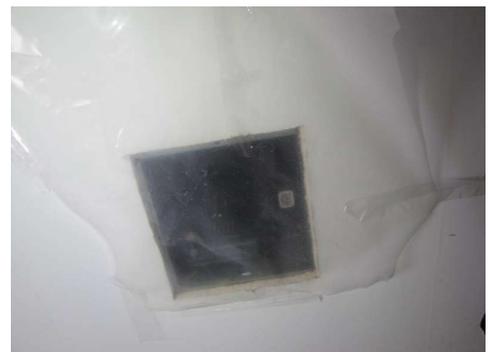
DAMAGED CEILINGS

Ceiling damage can present itself in a few different ways:

Contact a qualified professional.

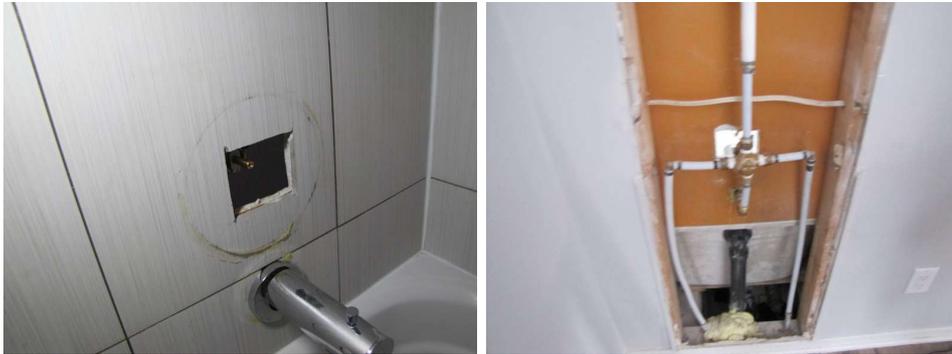
5.7.5 Bathrooms

FAUCET (TUB)

Missing tub faucet, will allow water infiltration.

Contact a qualified professional.

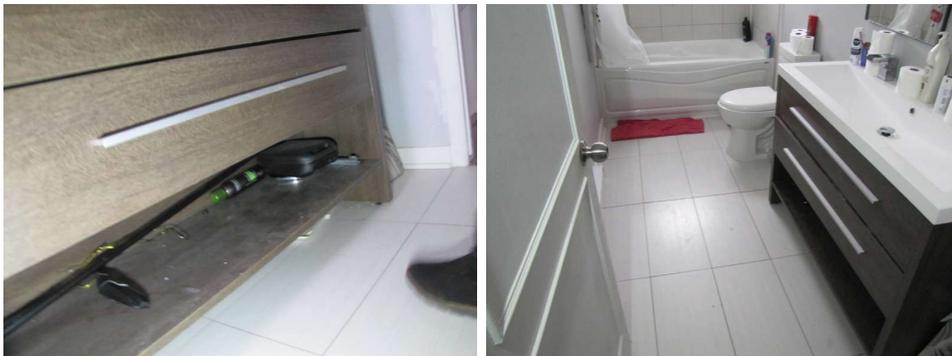
VANITY - DAMAGE

Vanity cabinet had a visible damage to the drawer that did not function properly.

Contact a qualified professional.

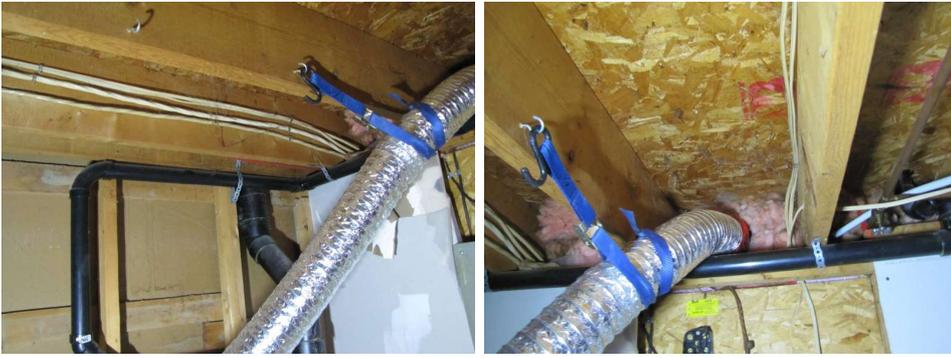
5.9.1 Laundry Room

DRYER DUCTING - NOT PROPER

Contact a qualified professional.

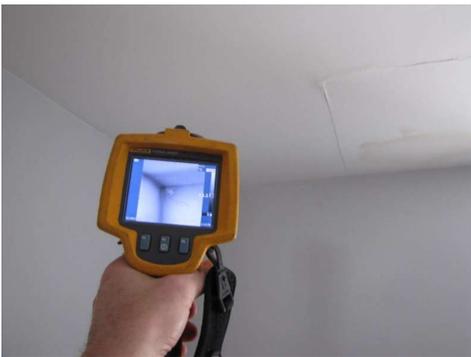
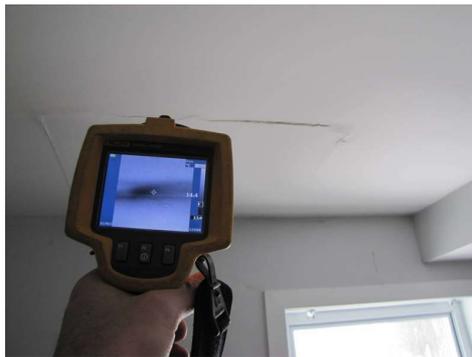
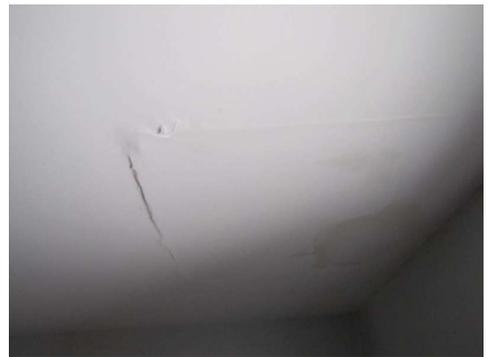
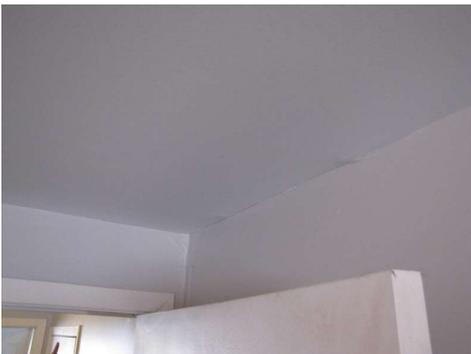
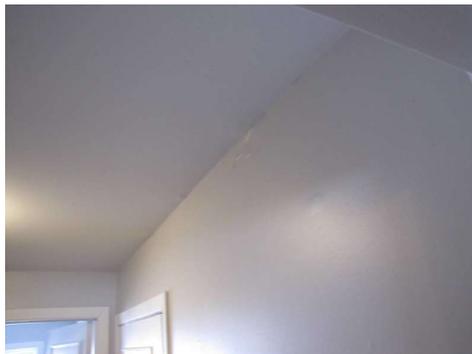
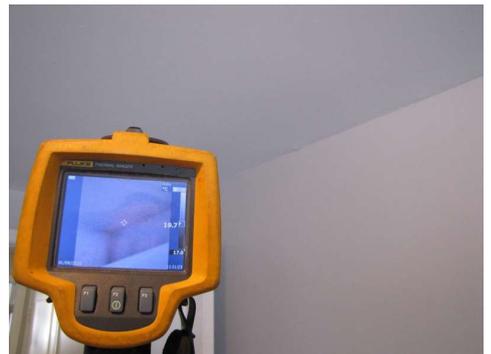
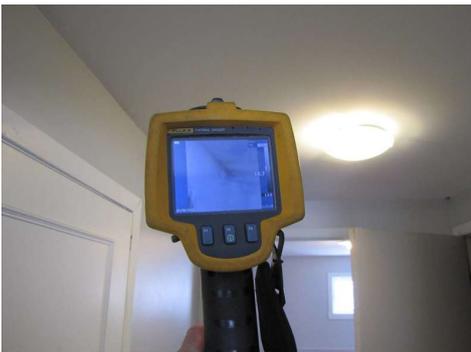
5.9.2 Laundry Room

WALLS -WATER DAMAGE

Visible water damage on the ceiling and the walls in the laundry room, hall and the bedroom, source of the leak should be determined and the wall fixed.

As per sellers declaration the faucet from the bathroom upstairs was leaking

Contact a qualified professional.

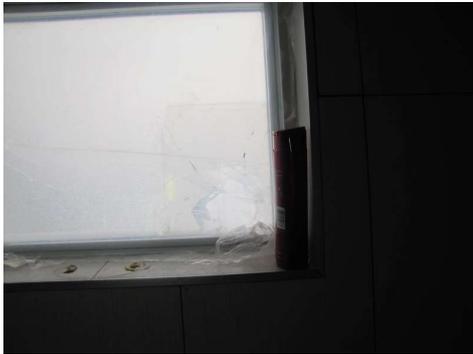
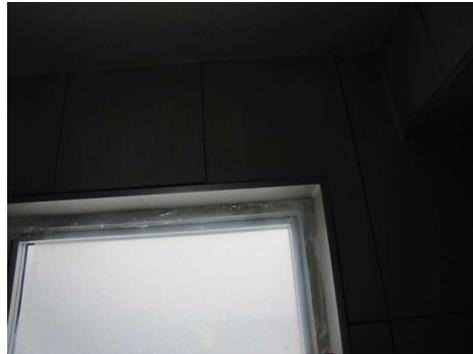
5.10.1 Windows - Interior View

WINDOW - CRACKED GLASS

Bathroom window had broken glass pane.

Contact a qualified professional.

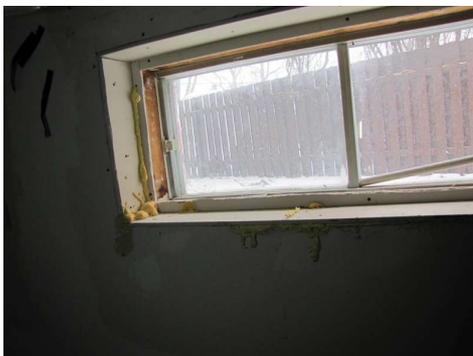
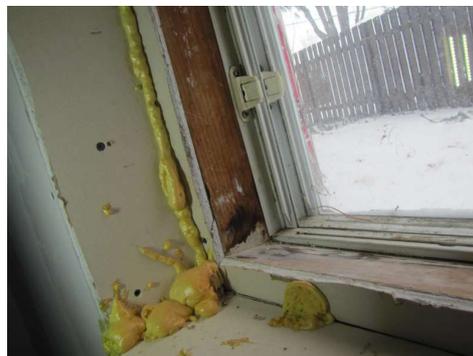
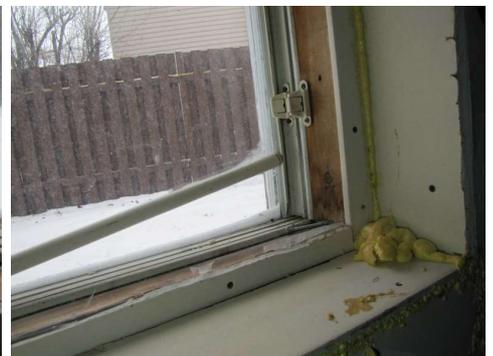
5.10.2 Windows - Interior View

WINDOWS - DETERIORATED

Water can also infiltrate through, and around, deteriorated windows

Contact a qualified professional.

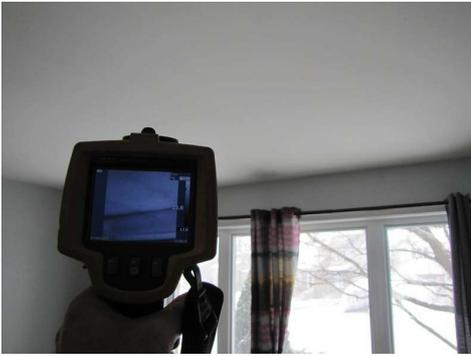
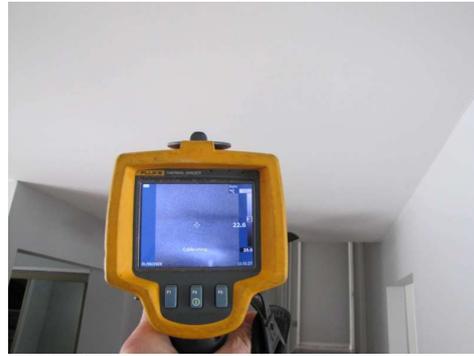
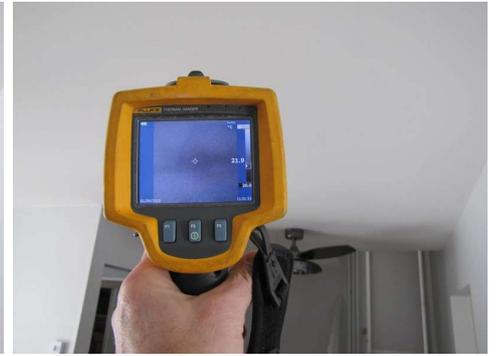
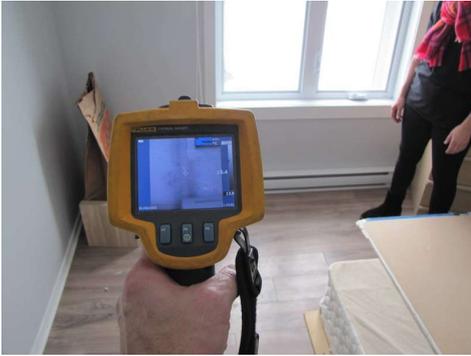
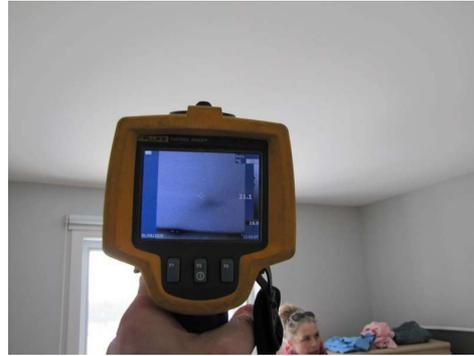
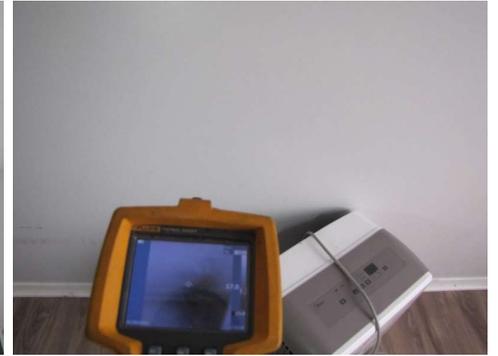
5.12.1 InfraRed Scan

COLD AIR INFILTRATION

Infrared scan showed few areas of cold air infiltration and possible elevated humidity. This is most likely due to poor insulation, breach in the vapor barrier or possible leak. We verified the area with humidity meter to ensure that there is no active leak,

Contact a qualified professional.

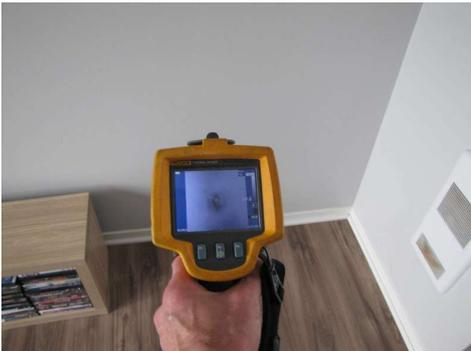
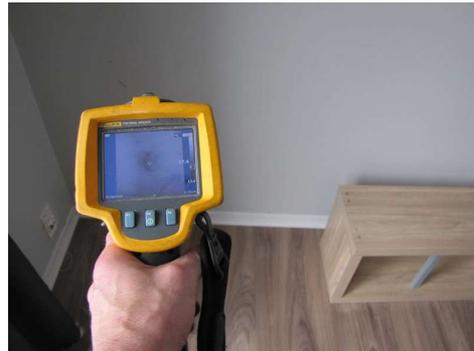
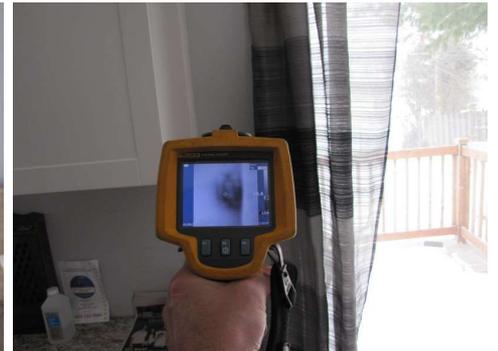
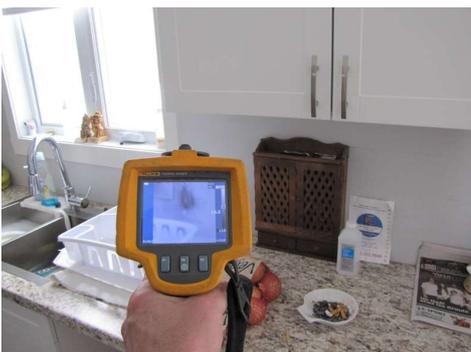
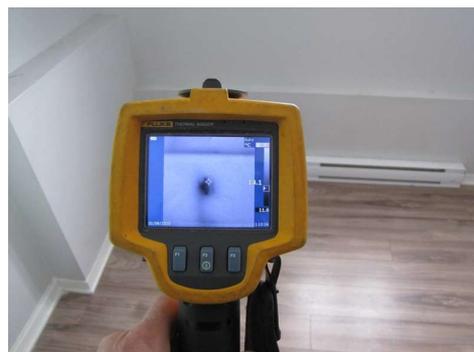
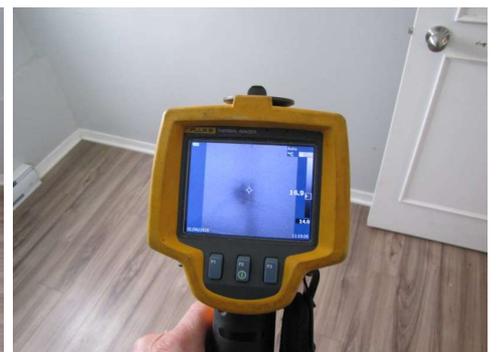
5.12.2 InfraRed Scan

LACK OF VAPOUR BARRIER

Due to lack of vapour barrier there is cold air infiltration through the plugs and switches.

Contact a qualified professional.

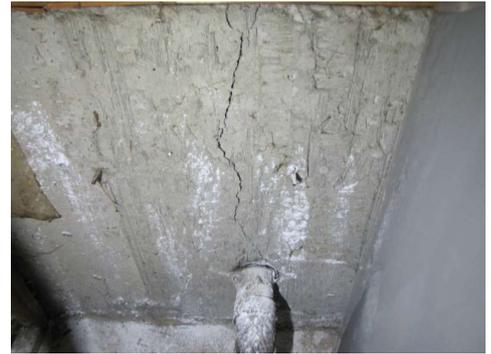
6.1.1 Foundation

FOUNDATION CRACKS - MINOR

Minor cracking was noted at the foundation. This is common as concrete ages and shrinkage surface cracks are normal. Recommend monitoring for more serious shifting/displacement.

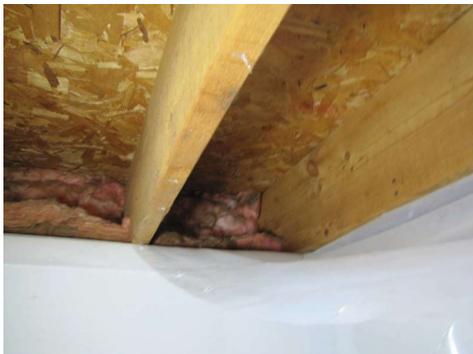
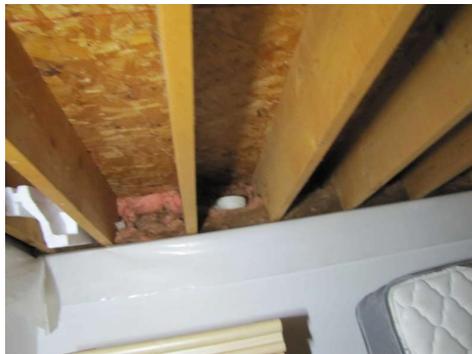
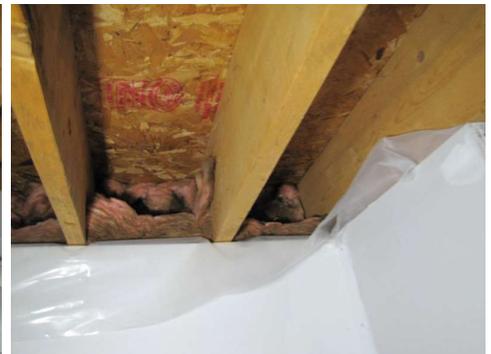
6.4.1 Wall Structure Interior Basement

RIM JOIST INSULATION - LACK OF VAPOR BARRIER

Vapor barrier should be installed over the insulation to avoid air infiltration.

Contact a qualified professional.

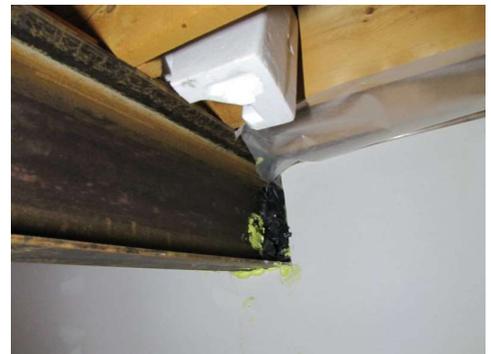
6.5.1 Structure - Visible from Inside

STEEL BEAM - LACK OF INSULATION

Contact a qualified professional.

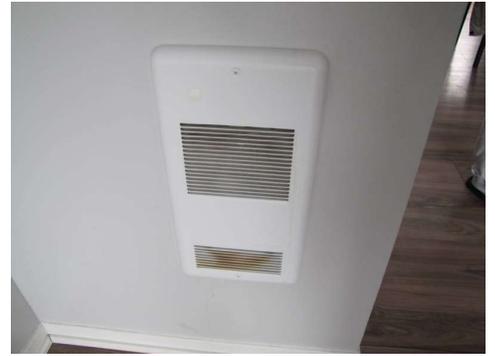
Recommendation
HEATER - OVERHEATING

Electric heater showed signs of over heating, recommended to have the heater verified and replaced if necessary,

Contact a qualified professional.

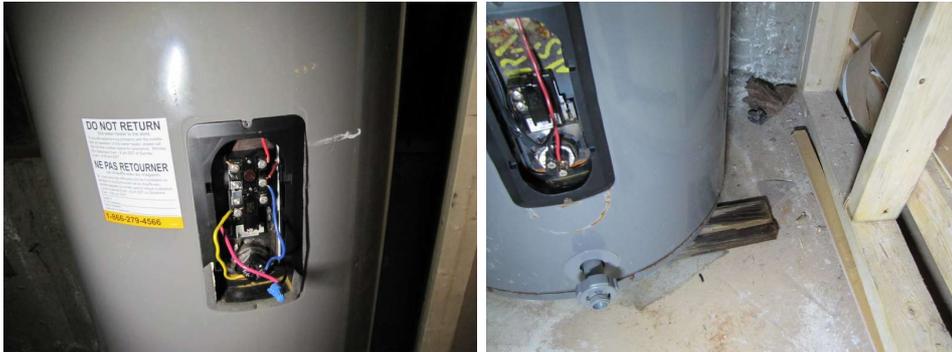
9.4.2 Hot Water Systems, Controls, Flues & Vents

WATER STAINS - LEAKAGE

Water stains were observed beneath water heater, indicating a past or present leak. The valve above the tank was leaking.

Recommend further evaluation and repair by a qualified plumber.

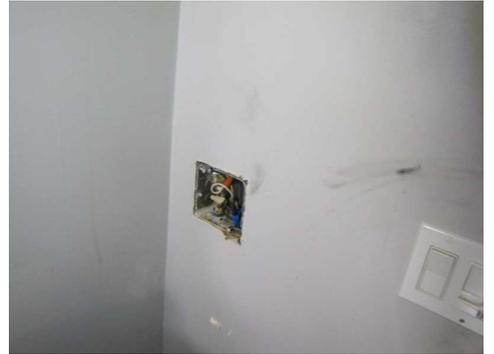
10.4.2 Lighting Fixtures, Switches & Receptacles

COVER PLATES MISSING

One or more receptacles are missing a cover plate. This causes short and shock risk. Recommend installation of plates.

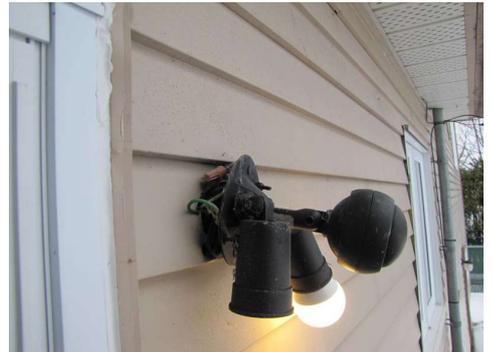
10.4.4 Lighting Fixtures, Switches & Receptacles

PLUG - MISSING

Exterior plug was missing at the time of the inspection, only the cover was installed.

Contact a qualified professional.

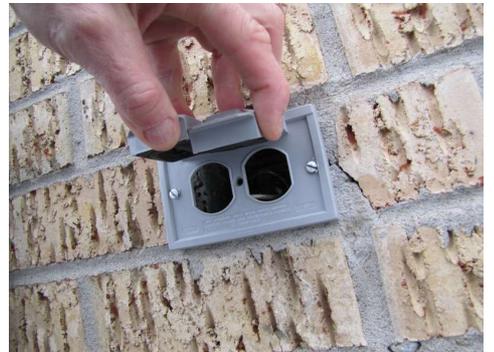
10.4.5 Lighting Fixtures, Switches & Receptacles

Plugs should not be installed over the heaters as it poses a fire hazard

Contact a qualified professional.

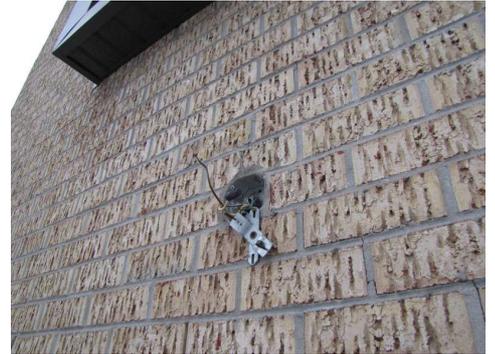
10.4.7 Lighting Fixtures, Switches & Receptacles

Over the garage door

HAZARDOUS ELECTRICAL CONNECTION

Improperly wired electrical connection may pose fire hazard.

Contact a qualified professional.

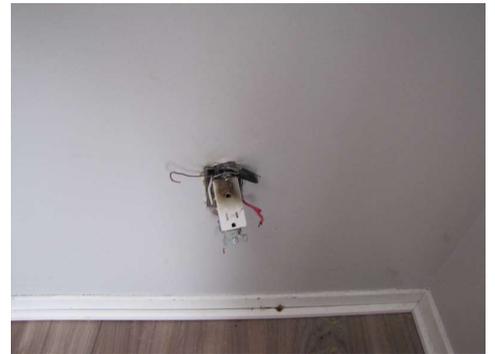
10.4.8 Lighting Fixtures, Switches & Receptacles

LIGHT FIXTURES INOPERABLE

One or more lights fixtures were not functioning . Replacement will be required

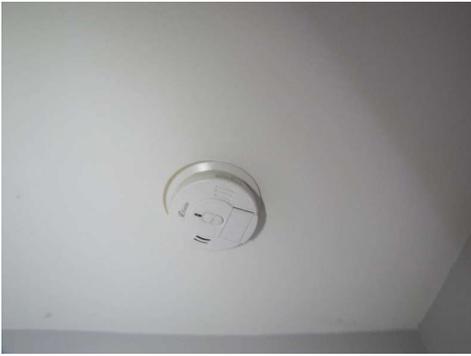
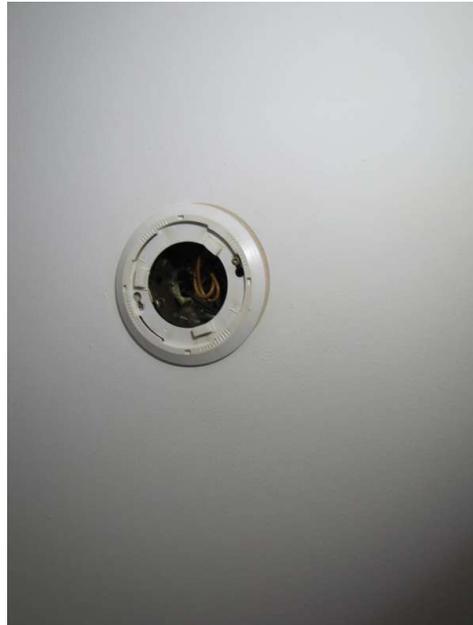
10.7.2 Smoke Detectors

SMOKE DETECTORS - NOT ENOUGH

Recommendation
Contact a qualified professional.

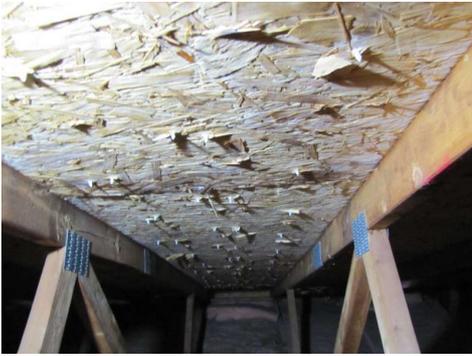
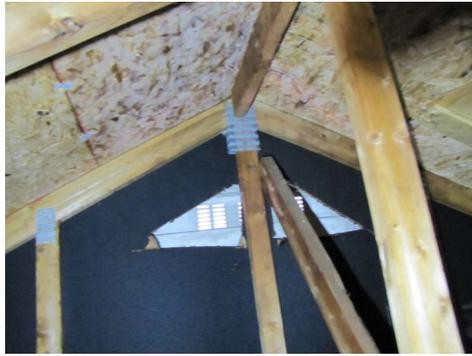
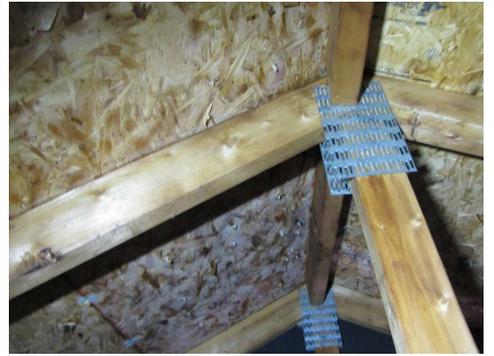
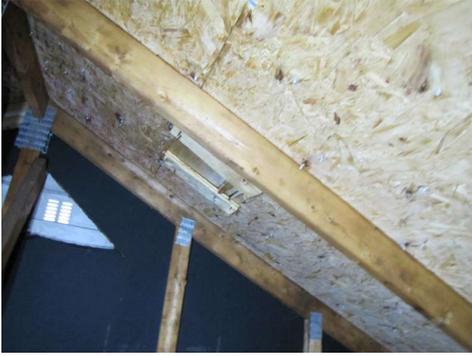
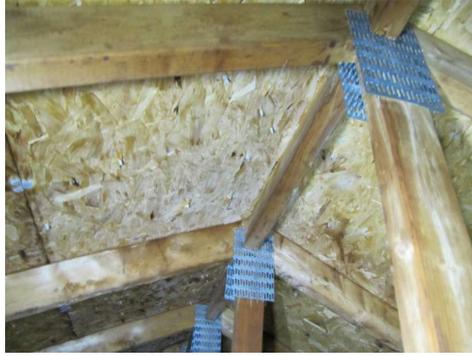
12.1.2 Attic Insulation

Over the living room

DISTURBED/INADEQUATE - INSULATION

Contact a qualified professional.

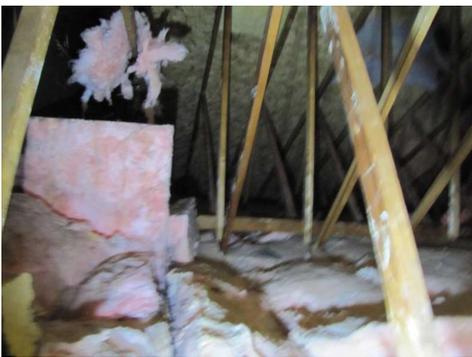
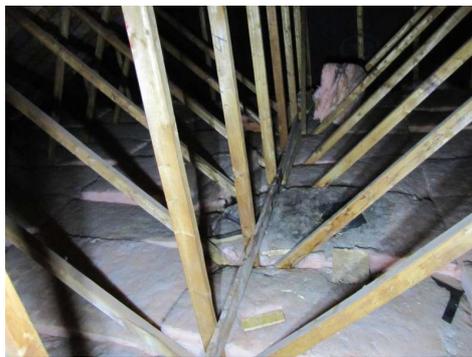
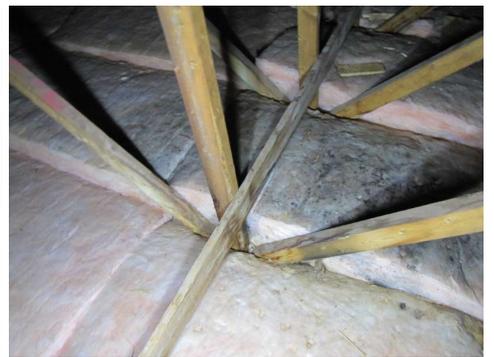
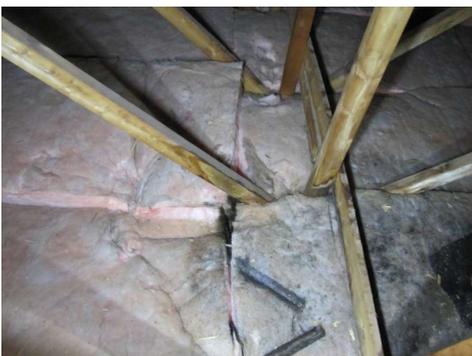
12.1.3 Attic Insulation

Over the kitchen

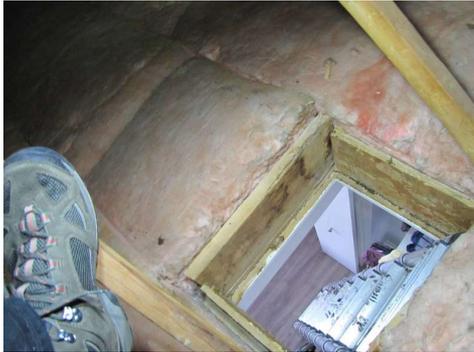
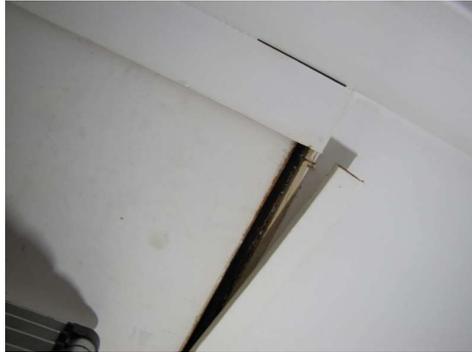
12.1.4 Attic Insulation

Insulation directly over the thermostat was singed and hot to touch, immediate thermostat replacement is required

Recommendation
Contact a qualified professional.

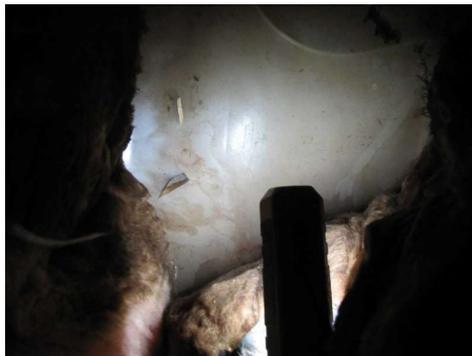
12.3.1 Ventilation

EXHAUST PIPE - NOT INSULATED

Contact a qualified professional.

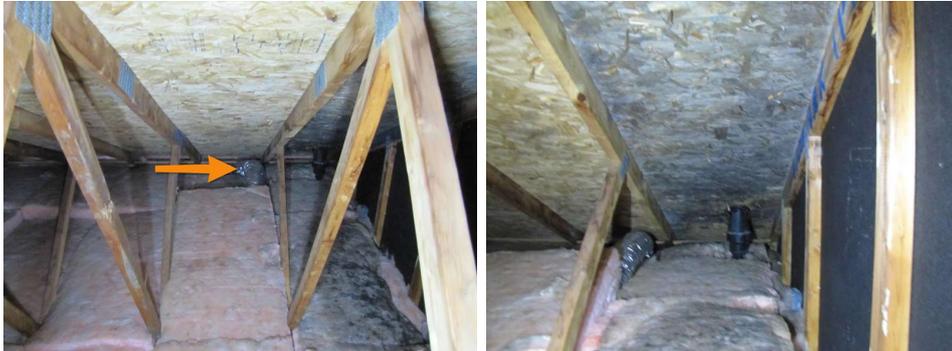
12.3.2 Ventilation

GABLE VENTS - NOT IDEAL

Gable end vents combined with a ridge vent tend to become intake vents feeding air flow currents created by air exiting at the ridge, thus failing to draw air up along the roof underside, failing to cool and dry that area, even if soffit intake venting is present.

Short circuits occur when air is caused to go around and away from its original and intended path, resulting in areas of the attic being bypassed. ... A power vent can pull in air (intake) from the roof louvers when it is supposed to be coming in exclusively through the soffit vents

Contact a qualified roofing professional.
