RESIDENTIAL REPORT

1234 Main St. St-Lazare QC J7T 3L7

Inspector
Karol Bartnicki

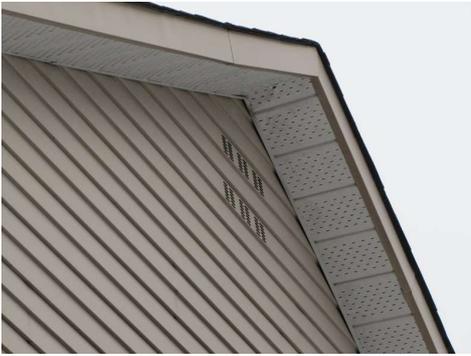
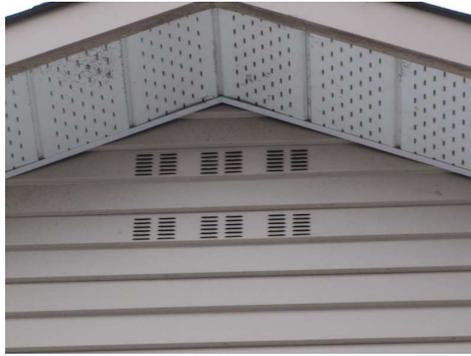
12.3.3 Ventilation

Block the gable vent

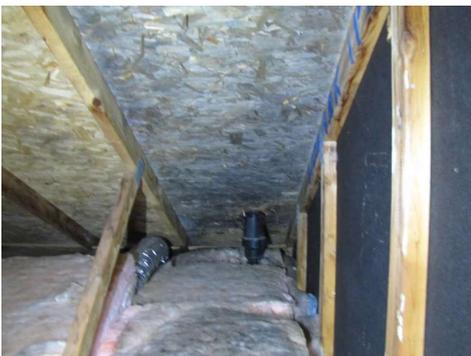
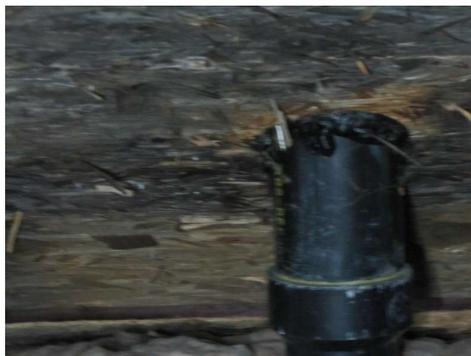
12.6.2 Roof Structure

TRUSSES - WATER STAINING

The primary cause of your attic-moisture problems results from warm air escaping from the heated portion of your home into the unheated attic space. ... This warm air condenses on the cold roof sheathing, causing frost and moisture issues.

Contact a qualified professional.

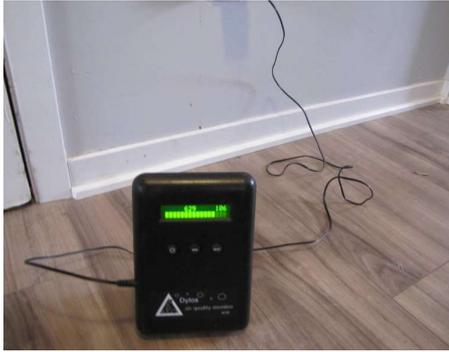
Air Quality: Air Quality Basement

Air quality test performed with Dylos DC1100 monitor. Small particles (fine dust, bacteria, mold, smoke, smog, etc.). Large particles (coarse dust, pollens, larger bacteria, plant spores, dust mite feces, etc.). Basement reading small 620, and large 106, this is fair quality of air

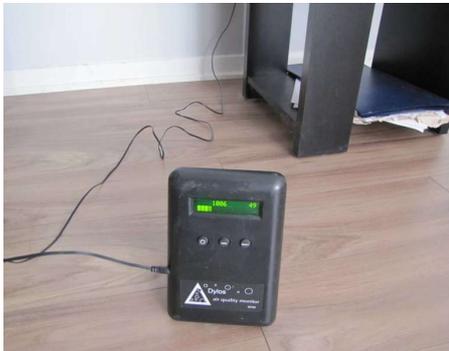
Air Quality: Air Quality Main Floor

Air quality test performed with Dylos DC1100 monitor. Small particles (fine dust, bacteria, mold, smoke, smog, etc.). Large particles (coarse dust, pollens, larger bacteria, plant spores, dust mite feces, etc.). Main floor reading small 1086 and large 49, this is fair quality of air

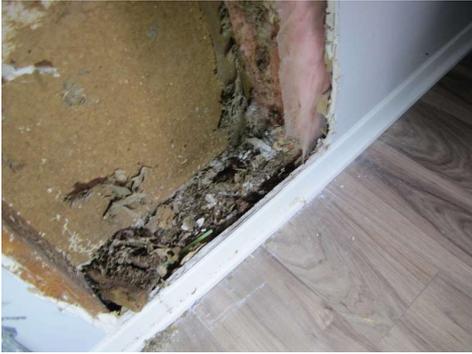
Front bedroom

WASPS NEST

Wasp nests were visible in the wall cavity. Recommend a qualified exterminator evaluate and recommend course of action.

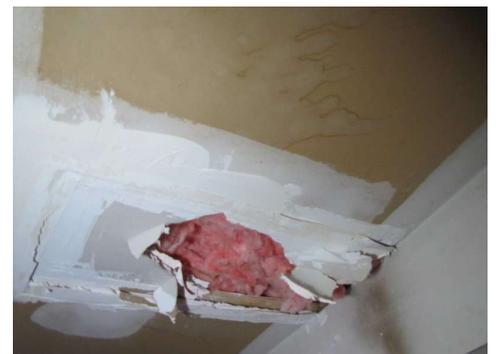
14.1.1 Ceiling

DAMAGED

Garage ceiling was damaged. Recommend qualified contractor evaluate and repair

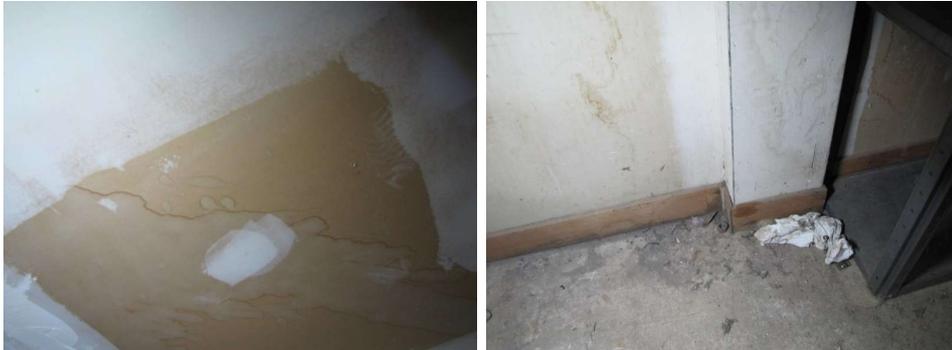
WATER STAINING

Visible water staining, most likely due to condensation. Back door damaged, large gaps under the main garage door

Contact a qualified professional.

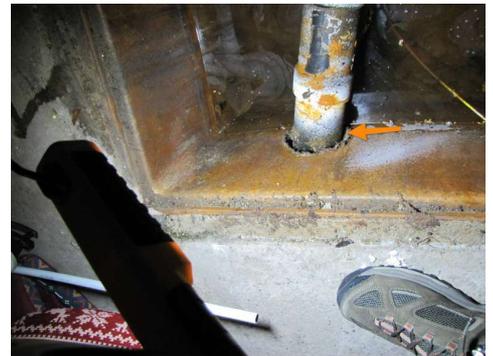
14.3.1 Drain

DRAIN - SEAL REQUIRED

Seal around the drain pipes is recommended for the drain pit. Also, the drain should be flashed once or twice a year.

Contact a qualified professional.

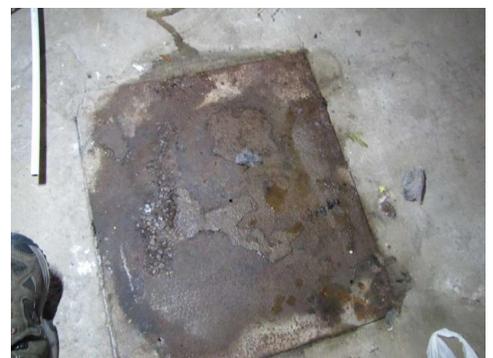
14.3.2 Drain

DRAIN COVER - DAMAGED

Drain cover was rusted and falling apart, this could pose a safety hazard.

Contact a qualified professional.

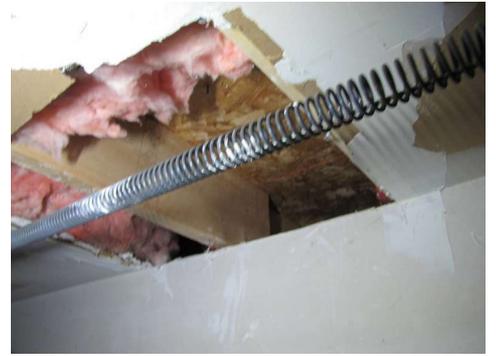
14.4.1 Walls & Firewalls

DAMAGED DRYWALL

Garage wall had damaged drywall. Recommend drywall contractor repair.

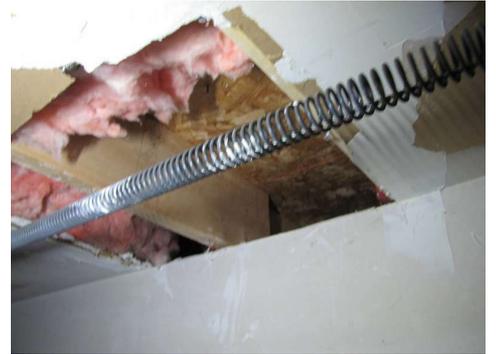
Firewall separating the home and garage is not compliant with modern building standards. Firewalls should be built with materials to prevent the spreading of a fire into the home living space. Recommend a qualified contractor evaluate and bring firewall up to standards.

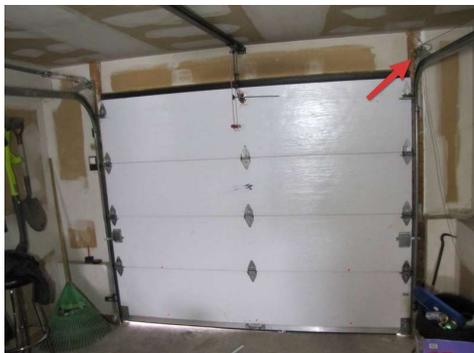
14.5.1 Garage Door

AUTO REVERSE SENSOR NOT WORKING

The auto reverse sensor was not responding at time of inspection. This is a safety hazard to children and pets. Recommend a qualified garage door contractor evaluate and repair/replace.

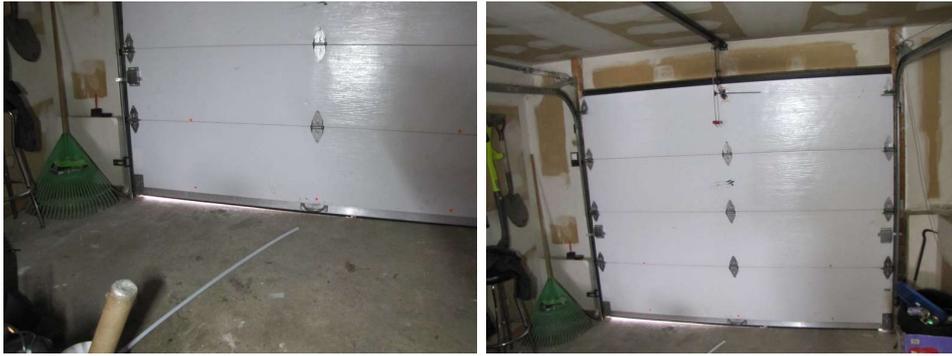
14.5.3 Garage Door

WEATHER STRIPPING - NOT EFFICIENT

Contact a qualified professional.

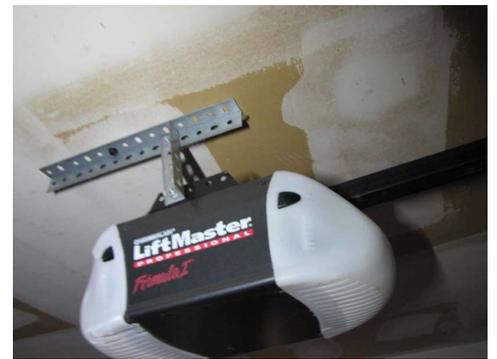
14.6.1 Garage Door Opener

INOPERABLE REMOTE

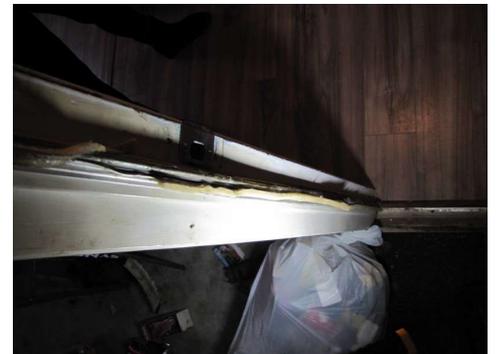
14.7.1 Occupant Door (From garage to inside of home)

DOOR DOES NOT MEET SEPARATION REQUIREMENTS

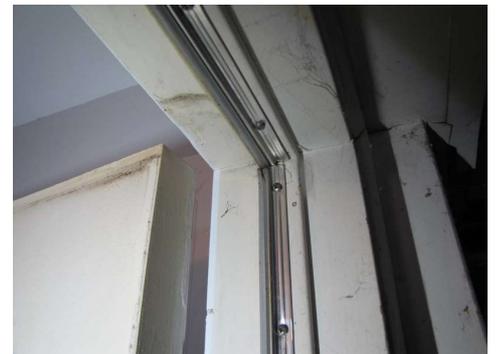
14.7.2 Occupant Door (From garage to inside of home)

NOT SELF-CLOSING

Door from garage to home should have self-closing hinges to help prevent spread of a fire to living space. Recommend a qualified contractor install self-closing hinges.

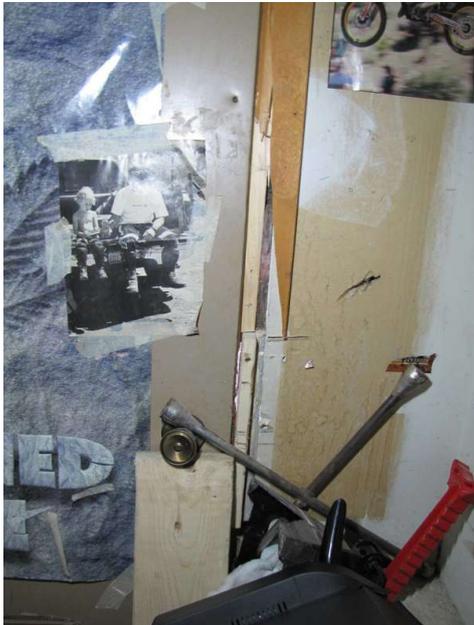
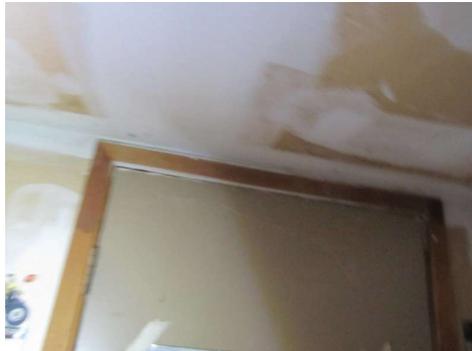
14.8.1 Side door from the Garage

SIDE DOOR - DETERIORATED

Noticeable deterioration on the side door, replacement will be necessary.

Contact a qualified professional.

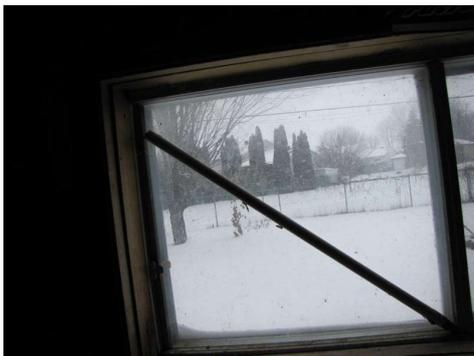
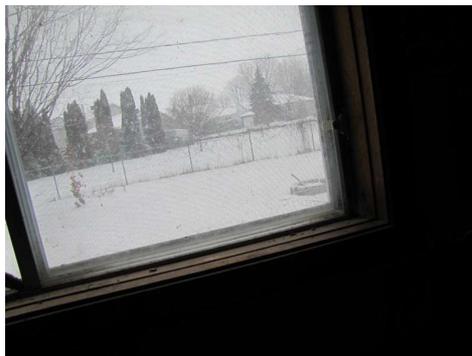
14.10.1 Windows

WINDOW - DETERIORATED

Single glass pane window in deteriorated condition, not providing the proper thermal barrier causing condensation

Contact a qualified professional.
